GRACE CHAPEL SITE DEVELOPMENT

ADDENDUM #1

Electrical Inspection report

Grace Chapel Property
106 Grace Chapel Rd.
Kingwood WV 26537

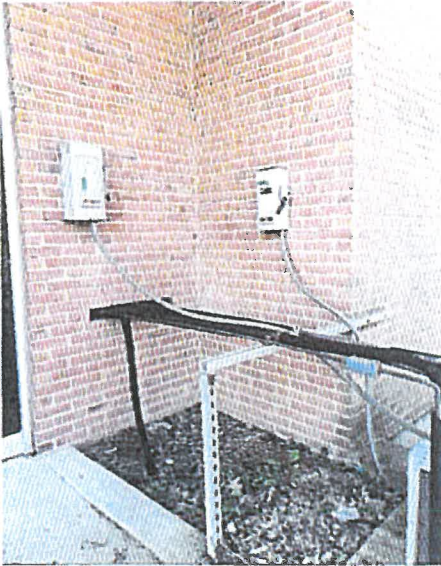
- 12) The two HVAC units outside of the glass doors will need their disconnects switches relocated due to inadequate access. The working space has been impeded by the copper lines for the units and you cannot stand directly in front of the disconnects to operate them.

HVAC Disconnects

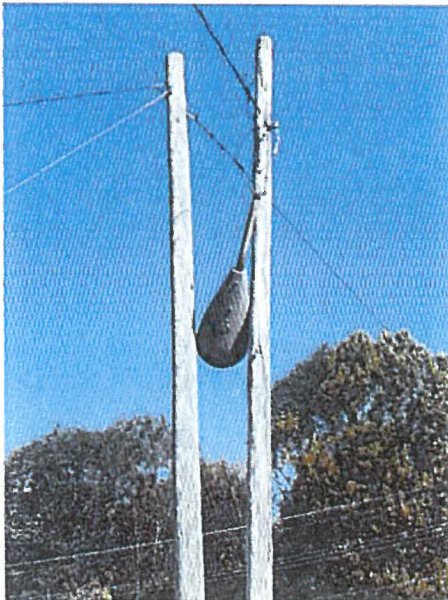
- 9) The parking lot and exterior outdoor lighting fixtures and wiring are deteriorated, and needs removed. Recommend the outdoor lighting, wiring and equipment be removed and a new lighting system be designed and installed per customers preference. The aerial cable entering the building has been installed incorrectly and will need to be reinstalled.

Parking lot lighting

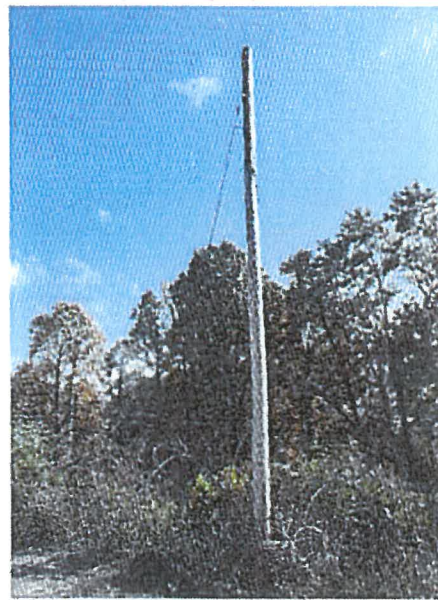
- 13) Aerial cable and some fixtures need to be removed because of electrical hazards that exist.

Aerial Cable

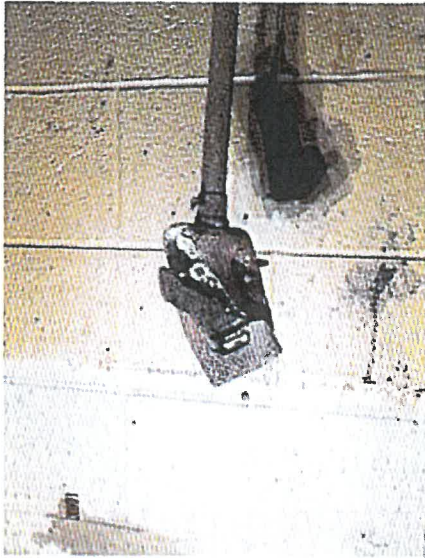
- 8) The conduits and electrical components in the acid room are severely corroded and needs attention. Recommend remove all components in this area and install new circuits to meet the current electrical needs. (Customer to designate what the room will be used for.)

Acid Room Conduits

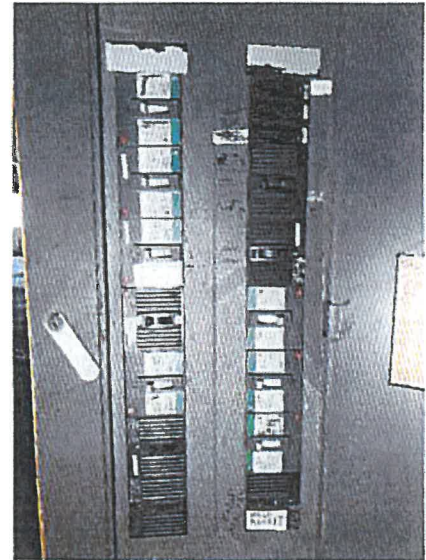
Obsolete Panel

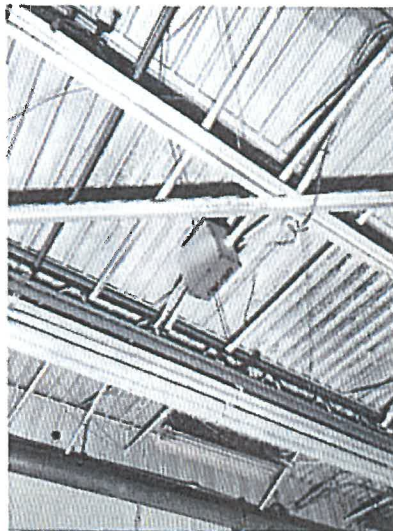
Unsupported Junction Box

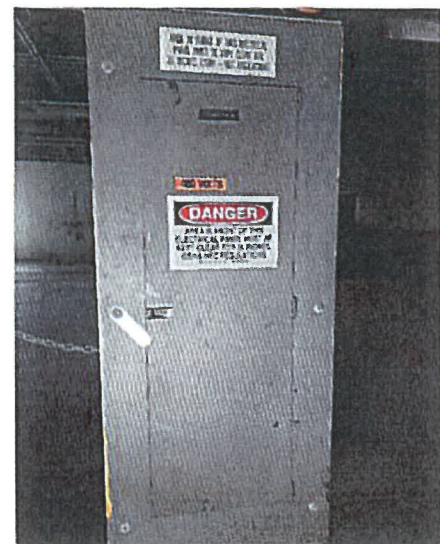
Panel Latch

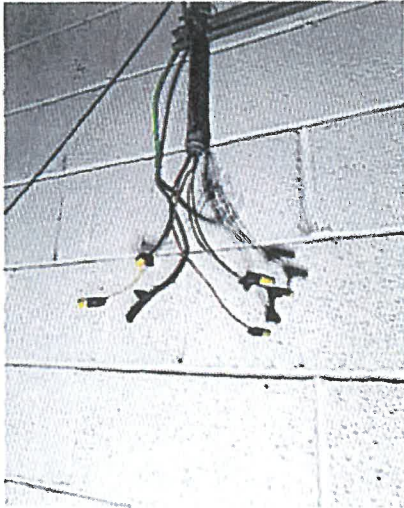
Exposed wiring

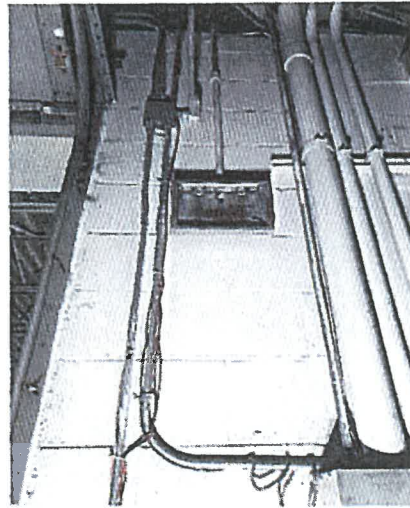
- 7) The Egress and Emergency lighting fixtures need to be replaced with LED working fixtures.
- 8) There are multiple junction boxes with open knockouts and improperly supported that will need replaced/repaired.

Exit Lighting

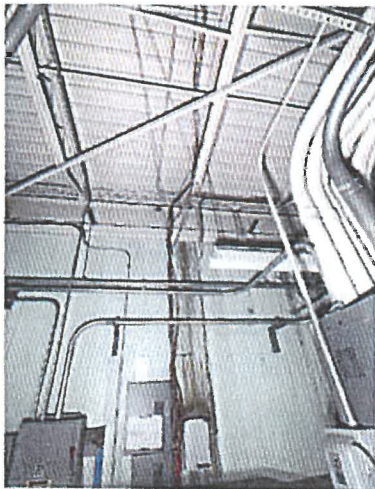
- 11) The networking cable that is ran throughout the building will need to be removed. The cabling is unorganized and unsecured. Recommend the cable to be permanently removed and reinstalled at a later date.

Networking Cables

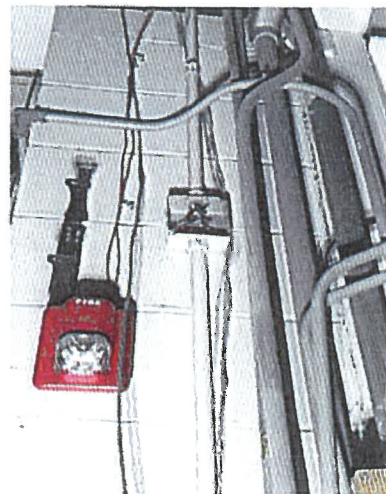
- Fire Alarm components missing throughout the building
- Missing devices may be smoke alarms, but without a blueprint or knowledge of the system setup it is unclear.
- Fire alarm cabling ran to junction boxes and just dead ended using wire nuts with no cover and can be easily seen from the ground.

Fire System
