HARRISON COUNTY PUBLIC SAFETY COMPLEX ROOF REPLACEMENT

ADDENDUM #1

October 28, 2019
Project No. 17-125

REPORT TRANSMITTAL
HARRISON COUNTY PUBLIC SAFETY COMPLEX
ROOF SAMPLING AND ANALYTICAL RESULTS
ASBESTOS CONTAINING BUILDING MATEREIALS

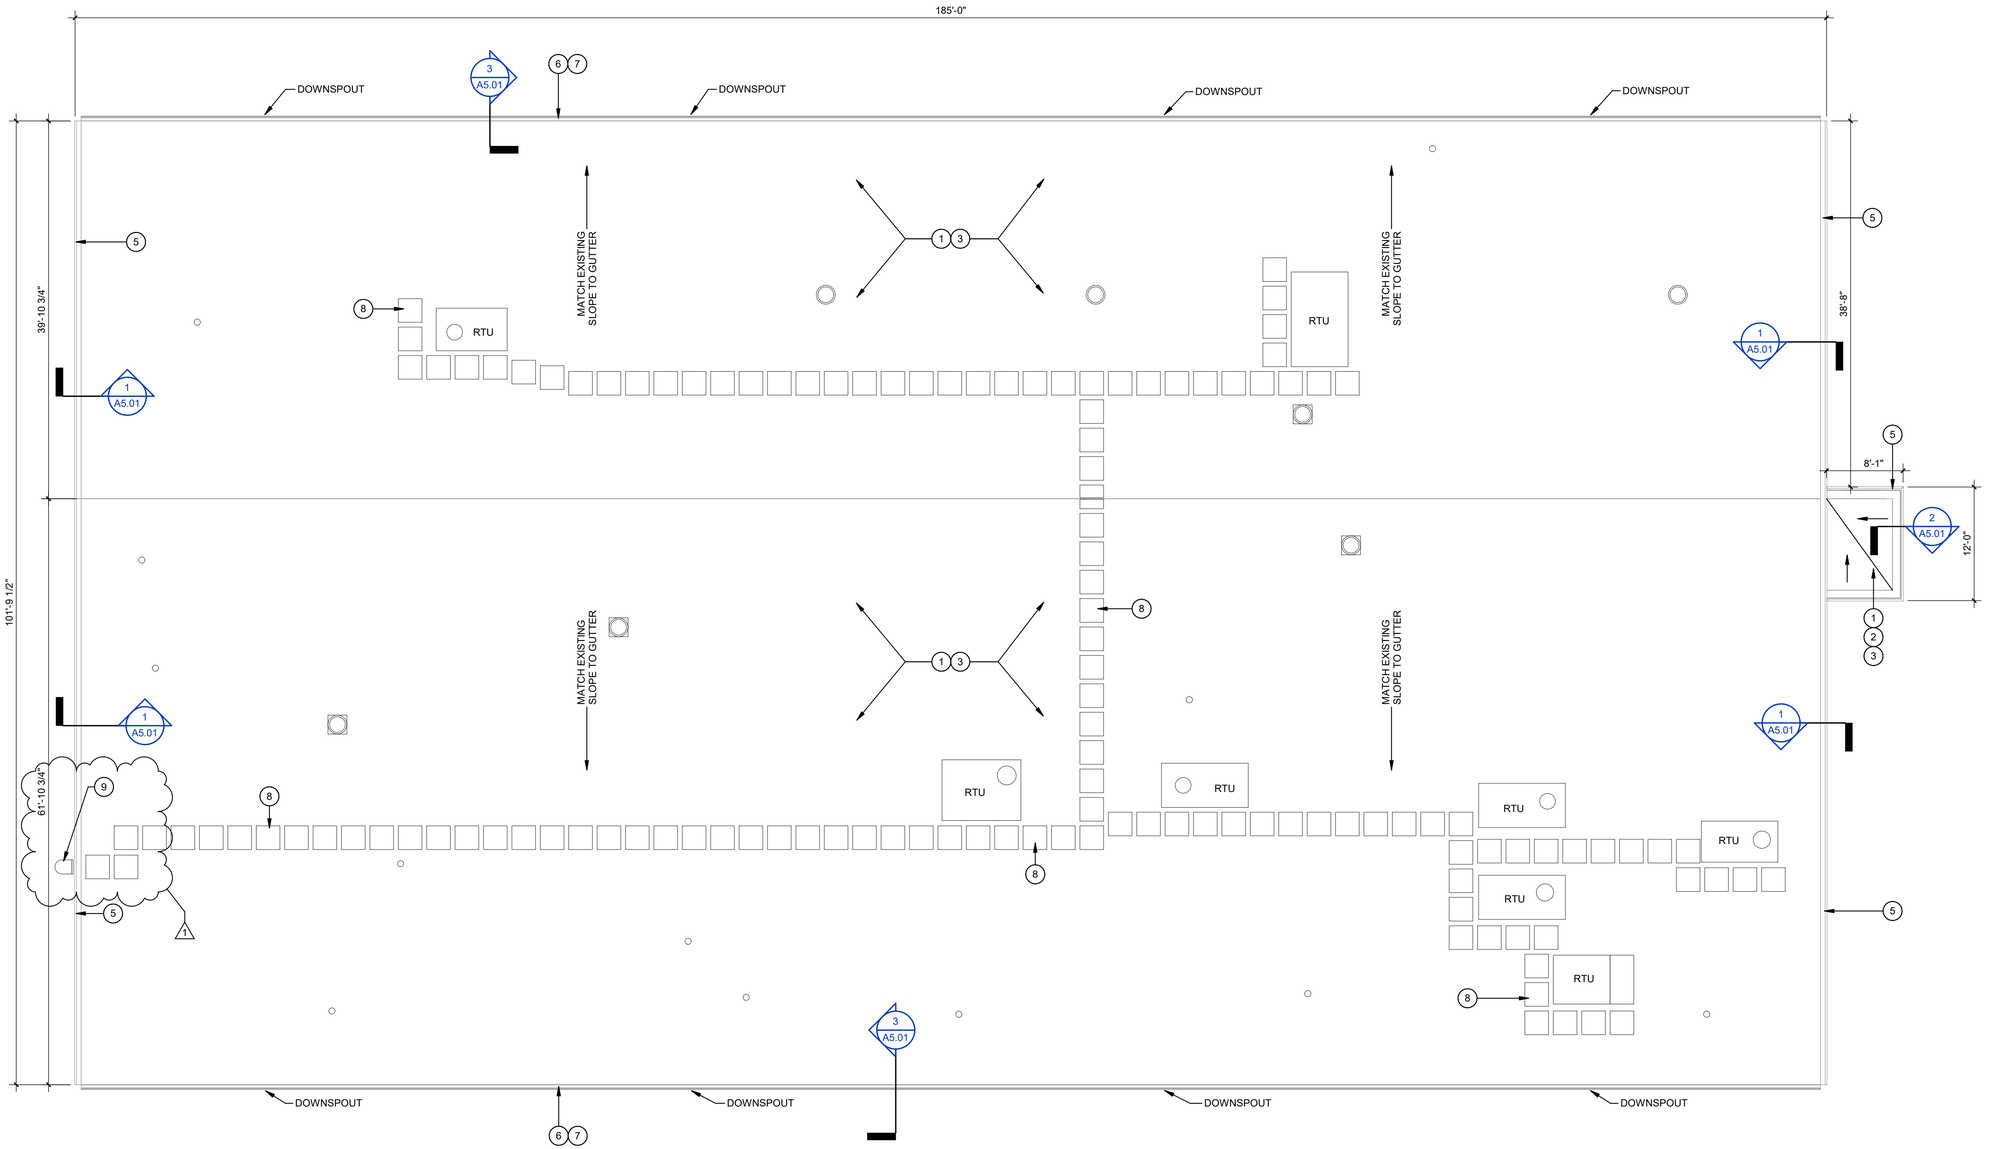
1 A1.01 ROOF PLAN - NEW CONSTRUCTION
1/8" = 1'-0"
0' 5' 10' 20'

1 INSTALL (2) LAYERS 2" POLYISO INSULATION
2 INSTALL 1/4" TAPERED INSULATION AS REQUIRED TO ENSURE POSITIVE DRAINAGE
3 INSTALL NEW 20 YEAR .060 FULLY ADHERED EPDM ROOFING SYSTEM OVER INSULATION
5 INSTALL METAL COPING
6 INSTALL GUTTER & DOWNSPOUT SYSTEM
7 RAISE ROOF EDGE AS REQUIRED FOR NEW INSULATION THICKNESS w/ 2x FULL WIDTH P.T. LUMBER ANCHOR BOLTED @ 48" O.C. MAX
8 INSTALL RUBBER WALKING PADS FOR ACCESS TO ALL HVAC EQUIPMENT AND NORMAL SERVICE AREAS
9 INSTALL WALL MOUNTED CAGED ROOF ACCESS LADDER. CONFIRM EXACT LOCATION WITH OWNER

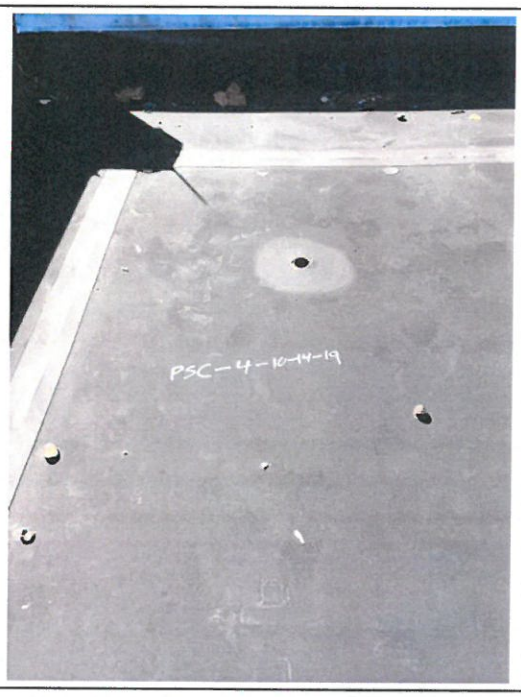
Photo No.:	Date:
4	10/14/2019

Roof 2

Roof Core Sample
PSC-4-10-14-19

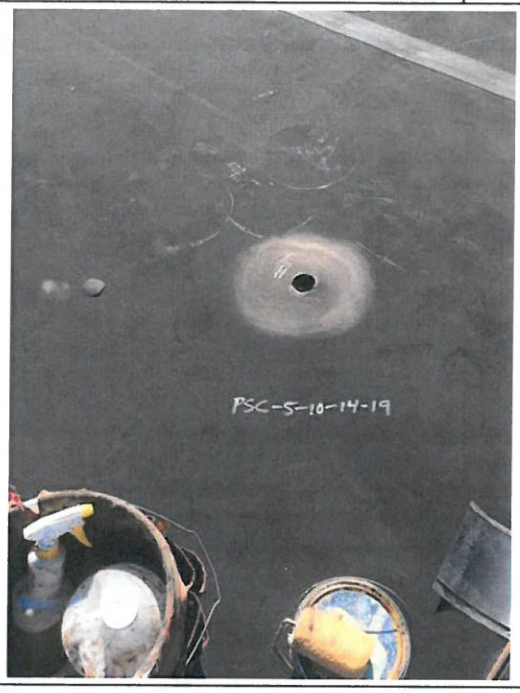
Photo No.:	Date:
5	10/14/2019

Roof 2

Roof Core Sample
PSC-5-10-14-19
